MODIS Imagery of Oil Slick in Gulf of Mexico (Apr. 2010)

April 25, 2010  
True-Color Image from MODIS  
Oil Leak from Damaged Well in Gulf of Mexico

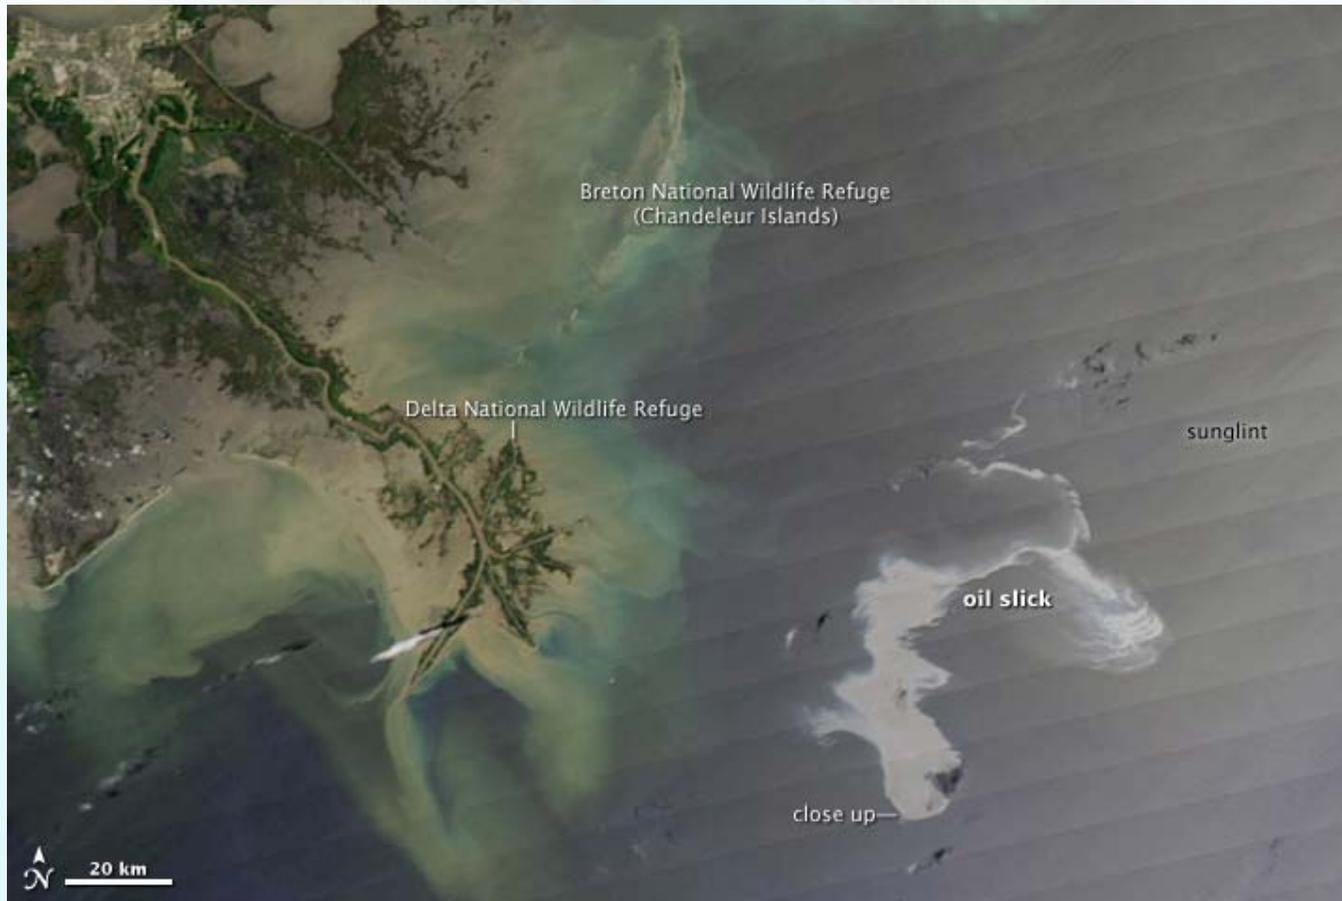
In this Moderate Resolution Imaging Spectroradiometer (MODIS) image, the Mississippi Delta is at image center, and the oil slick is a silvery swirl to the right. The oil slick may be particularly obvious because it is occurring in the sunlint area, where the mirror-like reflection of the Sun off the water gives the Gulf of Mexico a washed-out look. The close-up view shows waves on the water surface as well as ships, presumably involved in the clean up and control activities.
